EVALUATION OF XM20 A1.D XM20E1 LANDING MATS UNDER HEAVY-DUTY LOAD

Carroll J. Smith

December 1972

MISCELLANEOUS PAPER S-72-39

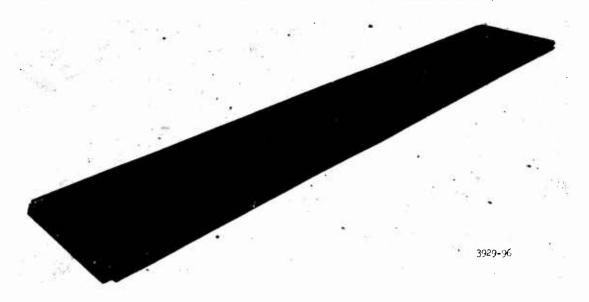
Fig. 1. XM20 landing mat panel
